CARDIVNSWC-TR-61-98-29

Survivability, Structures, and Materials Directorate
Technical Report

Crevice Corrosion Performance of Candidate Naval Ship Seawater Valve Materials in Quiescent and Flowing Natural Seawater

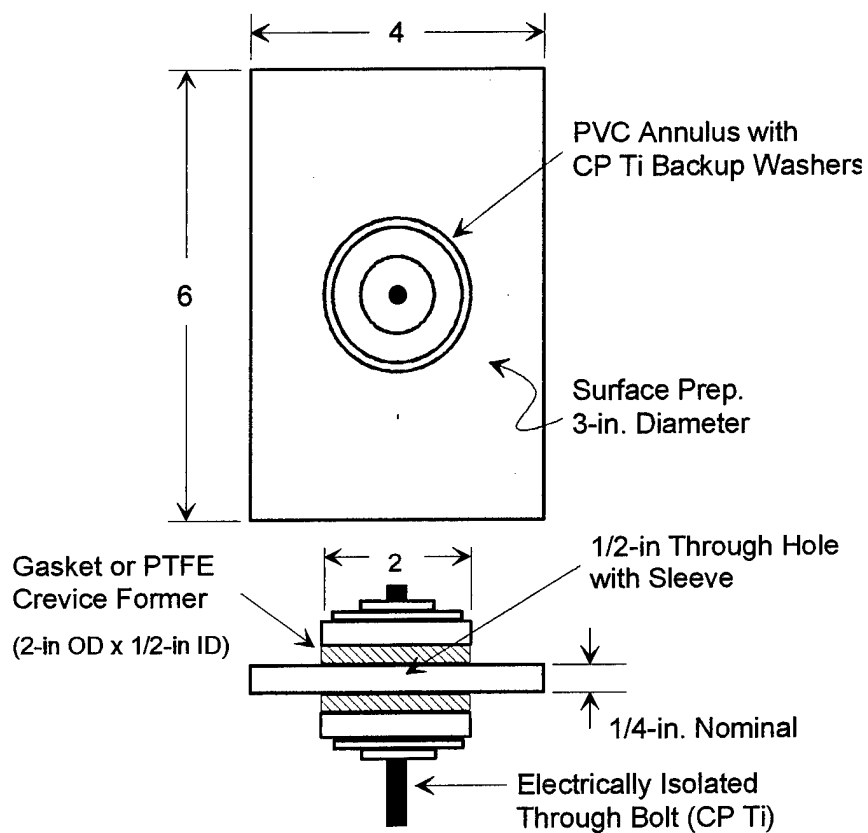
Figure 1. Crevice Corrosion Specimen Assembly
Used for Quiescent Exposures

Crevice corrosion specimen assemblies were immersed in constant temperature 85 ± 5 °F (29 ± 3 °C), quiescent, filtered natural seawater for a period of 180 days. The specimen assemblies consisted of two non-metallic disks attached to a 4 in. x 6 in. x nominally $\frac{1}{4}$ in. thick (10.2 cm x 15.2 cm x 0.6 cm) plate of the alloy being investigated, with crevices formed either by $\frac{1}{8}$ -in. (0.3 cm) thick gasket material (cloth inserted rubber per HH-P-151) or polytetrafluoroethylene (PTFE) with a specific gravity of 2.15 (Figures 1 and 2). Generally, rubber gasket material was used to form crevices on cast materials anticipated for valve bodies. This configuration replicated flange connections or valve bonnet connections. PTFE was generally used to form crevices on wrought materials. This configuration was intended to replicate crevices formed by "soft" seats on valve internal components.

The crevice assemblies were tightened to a torque level of 75 in-lbs (0.42 N-m) and immersed in seawater. Seawater was continuously provided to the test tanks during the test period at a rate of approximately 0.2 to 0.3 gal./min. (0.75 to 1.13 l/min.), equating to about 3.5 complete changes of seawater daily. Copper-based alloys were tested in a tank separated from other alloys (Alloy 400 was tested with the copper-base alloys). After testing, corroded specimens were acid cleaned in accordance with ASTM

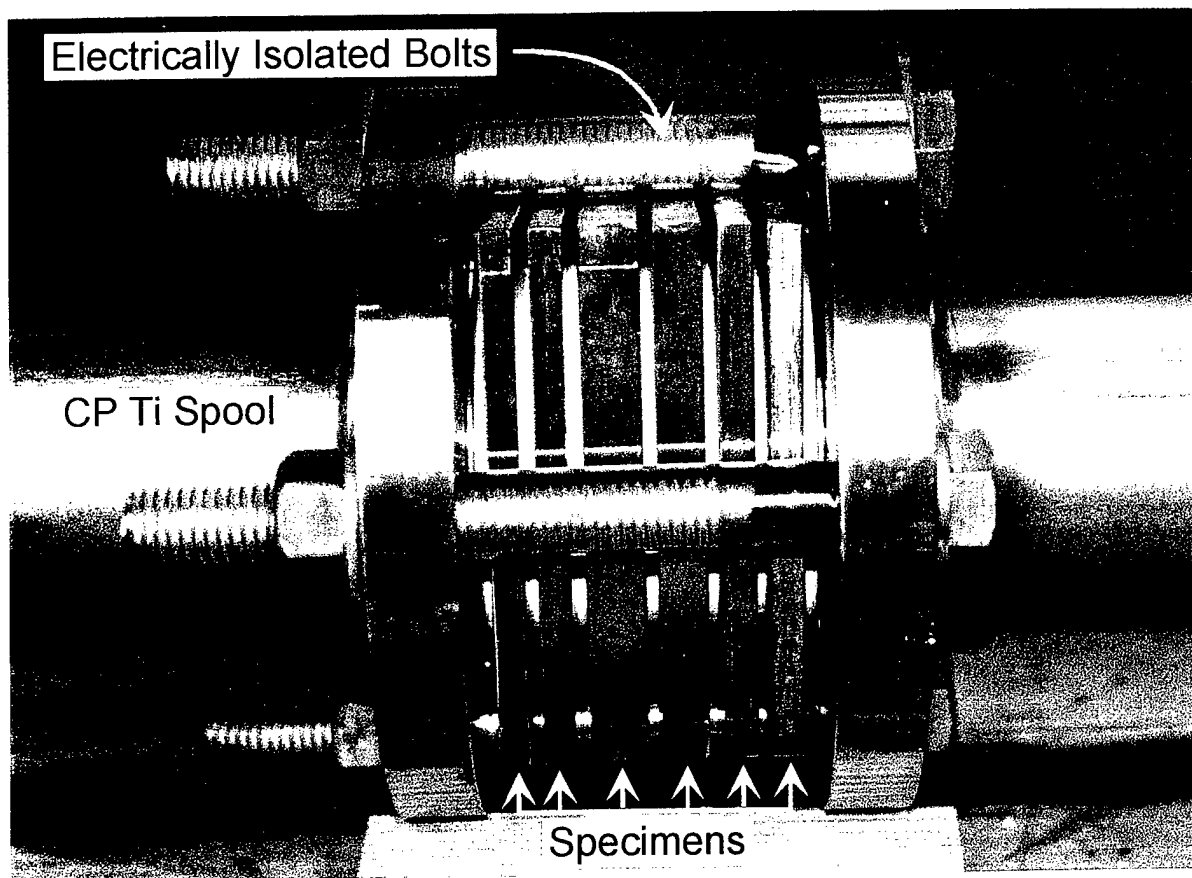
Figure 3. Specimen Assembly for Crevice Corrosion Tests in Flowing Seawater

In these tests, seawater was pumped through a series of cells consisting of 4-6 plate specimens containing a 2-in. (5.1 cm) diameter hole sandwiched between non-metallic crevice formers and flanged titanium spool pieces (Figures 3 and 4). Cells were assembled by placing the plate specimens over a centering device and applying a 200 psi (1.38 MPa) preload to the flange faces using a hydraulic press. The flange bolts were then torqued to 25 ft-lb (3.46 kg-m). This procedure was used in an attempt to produce consistent crevice tightness while also ensuring leak tight connections. The specimens were electrically isolated from the titanium spool pieces. Each specimen was 4 in. x 4 in. x nominally $\frac{1}{4}$ in. thick (10.2 cm x 10.2 cm x 0.6 cm) and contained a 2 in. (5.1 cm) diameter center bore and a 3 in. (7.6 cm) outer diameter crevice area. Like the quiescent seawater tests, rubber gasket material was generally used as a crevice former on materials anticipated for use as valve bodies while PTFE was generally used to form crevices on alloys anticipated as trim materials. The surface ground and phonographic surface finishes used in the flowing seawater tests were the same as those used in the quiescent tests. Duplicate specimens per alloy condition were evaluated. All alloys in the quiescent seawater tests except CP Ti, Ti-6Al-4V, and 90/10 Cu-Ni were included in these flowing seawater tests. Specimens were exposed to filtered, natural seawater maintained at a constant 85 ± 5 °F (29 ± 3 °C) temperature and flowing at a velocity of 6 ft/sec (1.8 m/sec) for a period of 180 days. Prior to testing, all specimens and titanium components were detergent/pumice scrubbed with a bristle brush, then water rinsed and degreased with acetone. Crevice corrosion resistance of the alloys in flowing seawater was assessed in terms of mass loss, number of initiated crevice sites, and maximum depth of attack.

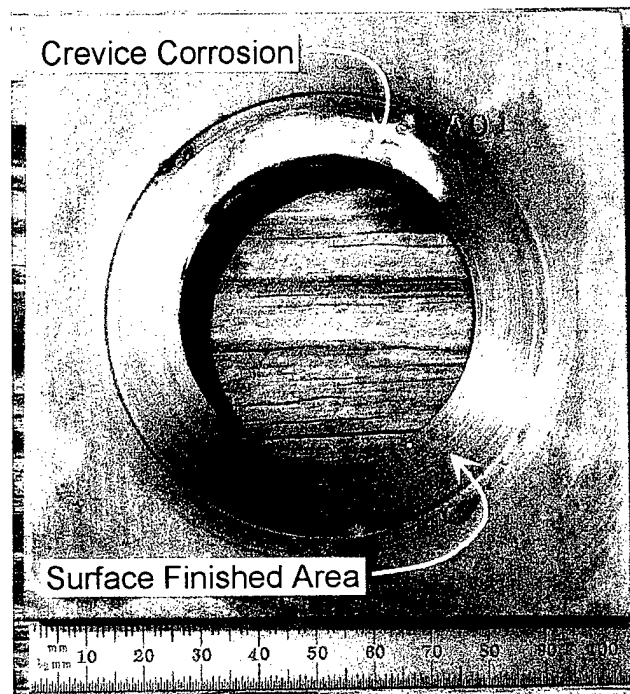
Figure 4. Crevice Corrosion Test Specimen (Flowing Seawater)

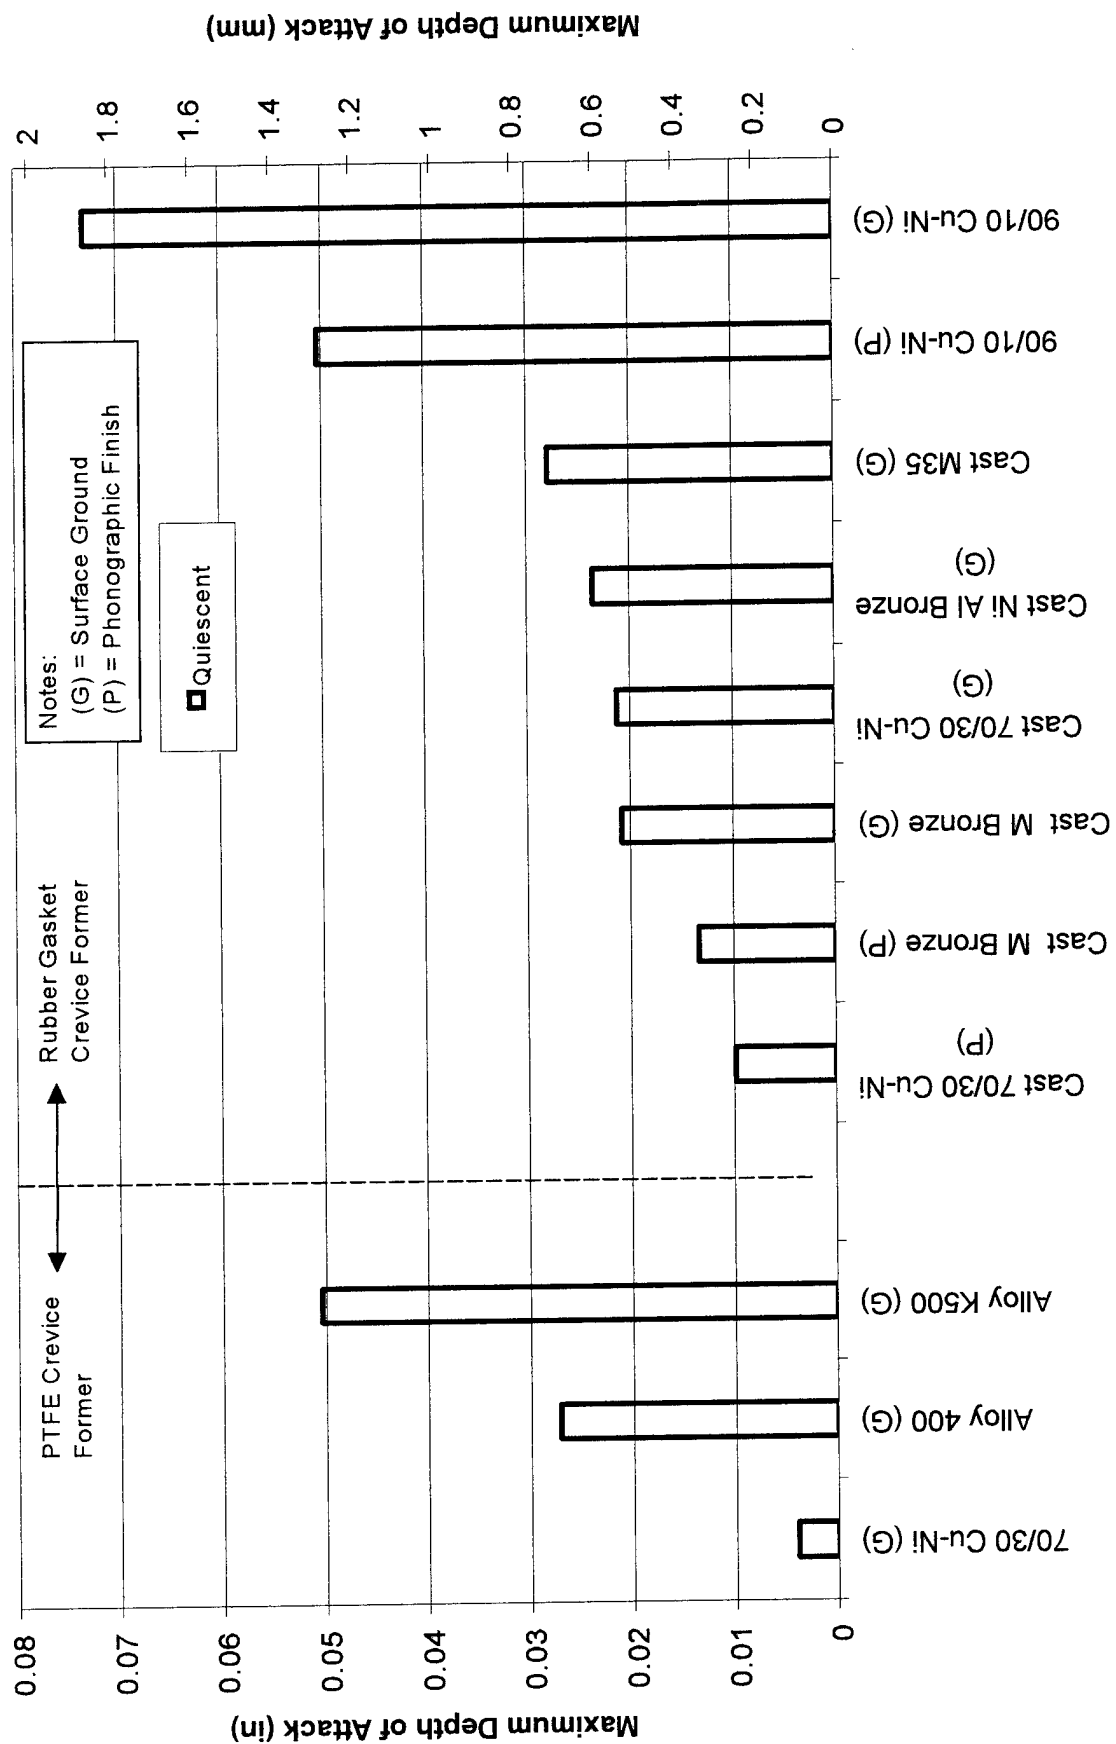
Figure 5. Maximum Depth of Attack Data for Bronze, Copper-Nickel and Nickel-Copper Corrosion Specimens After 180 Days in Quiescent Natural Seawater

Crevice corrosion results for these alloys are found in Table 4. All of the bronze, copper-nickel, and nickel-copper alloys exhibited crevice-related corrosion. In comparing the alloys based on the maximum depth of attack (Figure 5), the top performers in order from most-to-least resistant are wrought 70/30 Cu-Ni (surface ground), Cast 70/30 Cu-Ni (phonographic finish), M Bronze (phonographic finish), and M Bronze (surface ground).

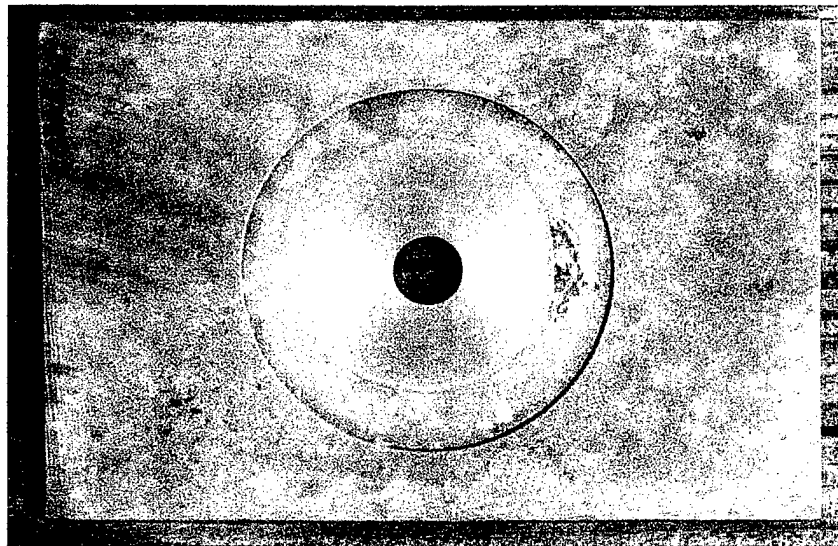
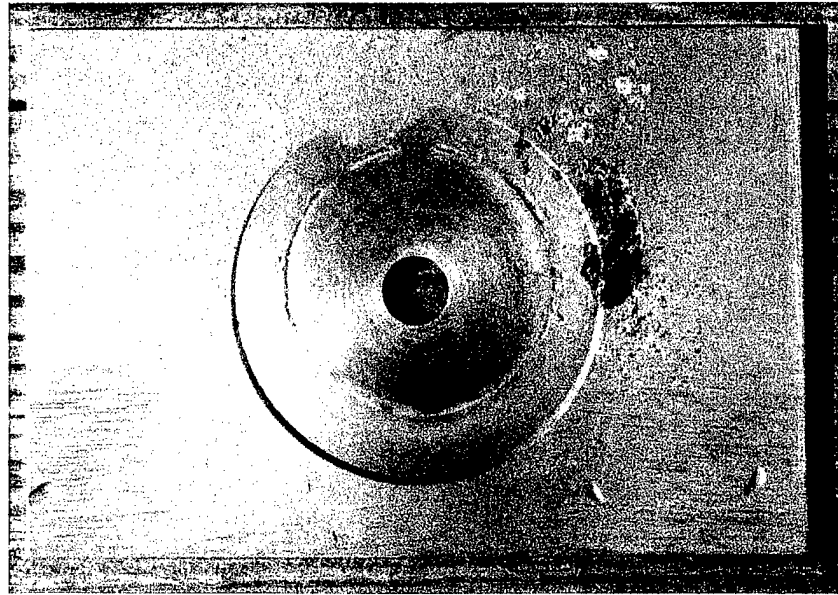
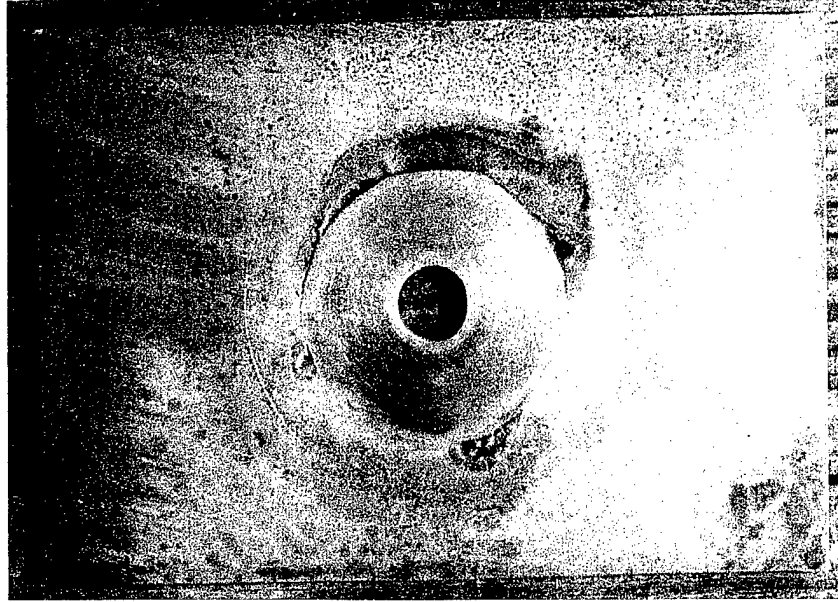
Figure 6. Cast M Bronze, Cast Ni Al Bronze, and Wrought 90/10 Cu-Ni Crevice Specimens After 180 Days in $85 \pm 5^\circ\text{F}$ ($29 \pm 3^\circ\text{C}$) Quiescent, Natural Seawater

Crevice attack of the M Bronze, Ni Al Bronze, and 90/10 Cu-Ni specimens was concentrated immediately adjacent to the crevice, which is common for copper alloys^{1,2} (Figure 6). Alloy 400, Alloy K500, and cast M35 all exhibited light corrosion within the crevice and more significant attack adjacent to the crevice former. For Alloys 400 and K500, gravity influenced the extent of crevice corrosion well beyond the crevice sites. These alloys also exhibited pitting on the boldly exposed surfaces (outside the machined area), with more numerous but smaller pits present on the Alloy 400 specimens than on Alloy K500. Pit depths ranged from 0.003 in. (0.07 to 0.08 mm) for Alloy 400 and 0.002 to 0.004 in. (0.04 to 0.09 mm) for Alloy K-500. Pitting of Alloy 400 and K500 in quiescent or low velocity seawater is typical². Cast M35 also experienced localized corrosion on the boldly exposed surfaces. Figure 7 includes representative photographs highlighting the variation in corrosion present on Alloy 400, Alloy K500, and cast M35. Wrought 70/30 Cu-Ni exhibited minimal corrosion both at and adjacent to the crevice mouth; a greater degree of crevice corrosion was found on the cast 70/30

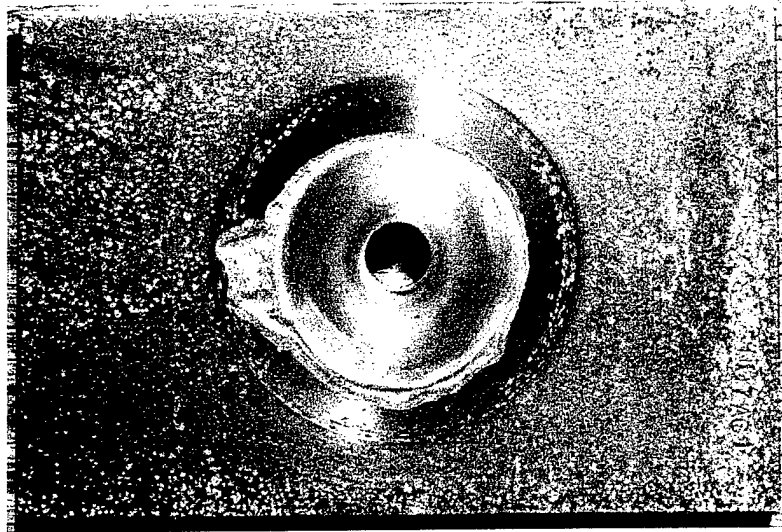
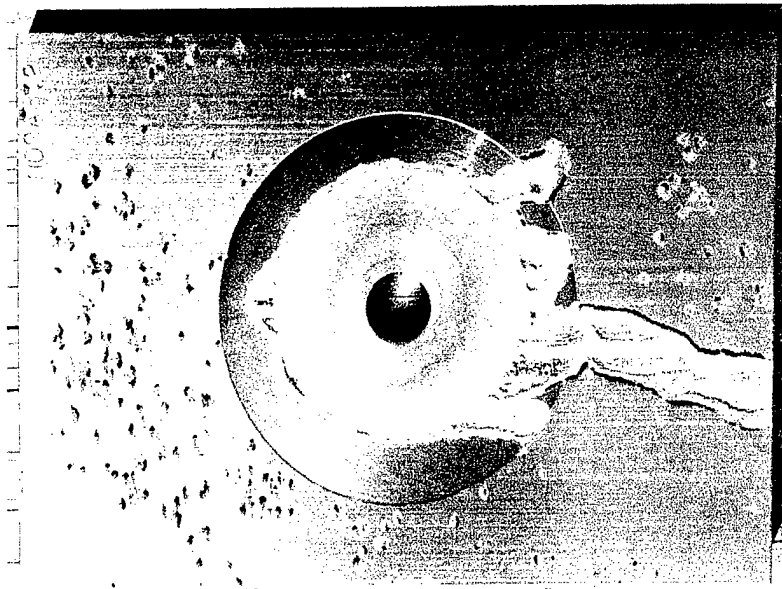
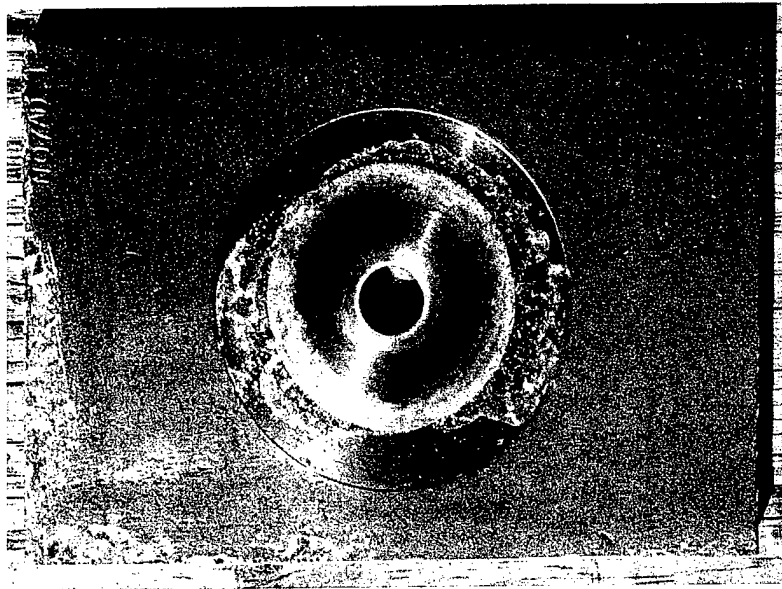
Figure 7. Wrought Alloy 400, Wrought Alloy K500, and Cast M35 Crevice Specimens After 180 Days in $85 \pm 5^\circ\text{F}$ ($29 \pm 3^\circ\text{C}$) Quiescent, Natural Seawater

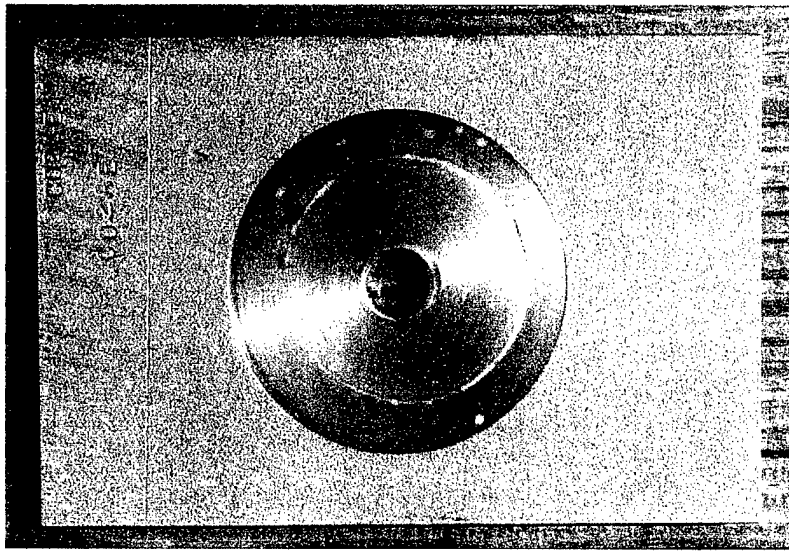
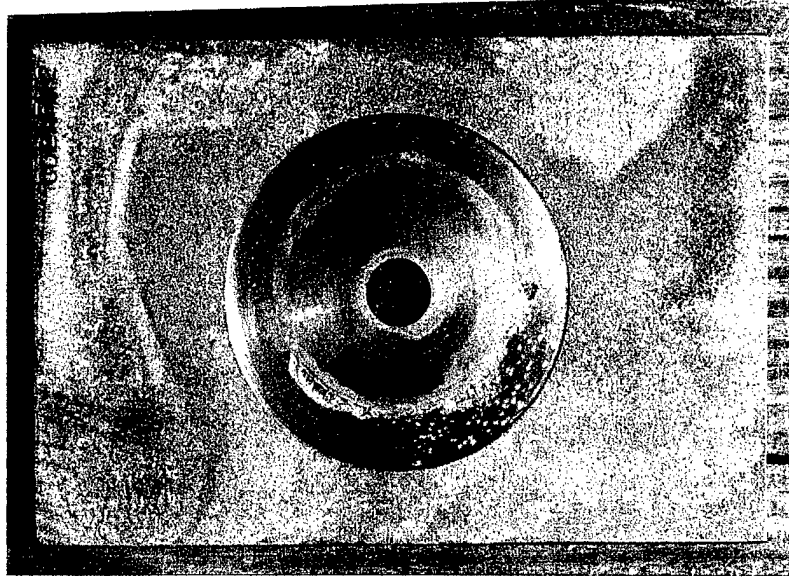
Figure 8. Representative Condition of Wrought and Cast 70/30 Cu-Ni Crevice Specimens After 180 Days in $85 \pm 5^\circ\text{F}$ ($29 \pm 3^\circ\text{C}$) Quiescent, Natural Seawater

Cu-Ni specimens as shown in Figure 8. For the three alloys where both surface ground and phonographic finishes were evaluated (M Bronze, cast 70/30 Cu-Ni, and 90/10 Cu-Ni), specimens with the phonographic finish exhibited slightly increased crevice corrosion resistance as compared to the corresponding surface ground specimens. Figure 9 highlights the difference in surface finish for the cast 70/30 Cu-Ni specimens.

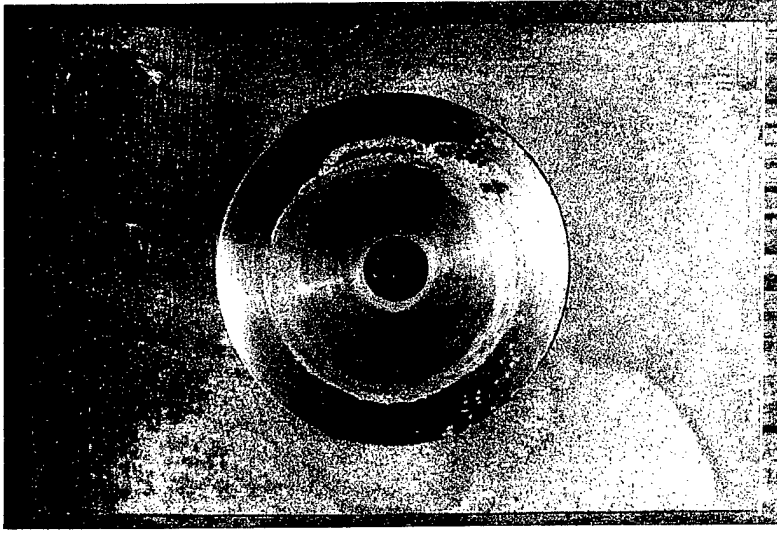
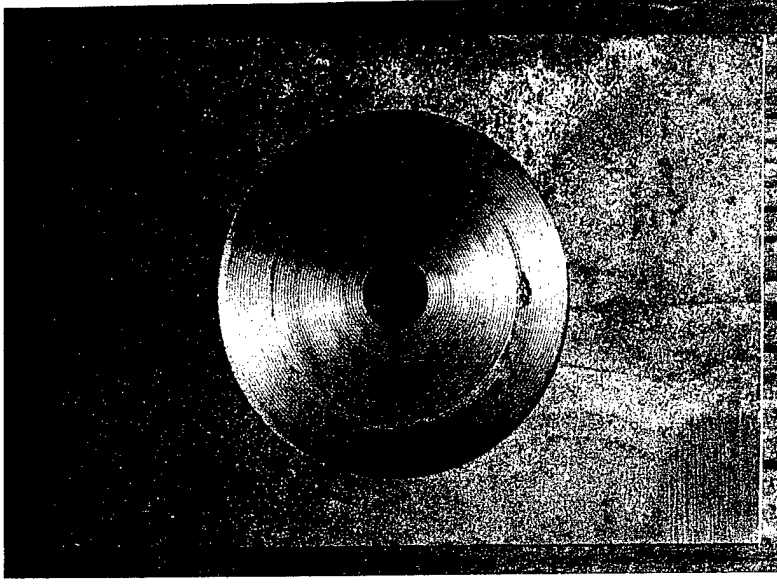
Figure 9. Cast 70/30 Cu-Ni Crevice Specimens with Surface Ground and Phonograph Finishes After 180 Days in $85 \pm 5^{\circ}\text{F}$ ($29 \pm 3^{\circ}\text{C}$) Quiescent, Natural Seawater

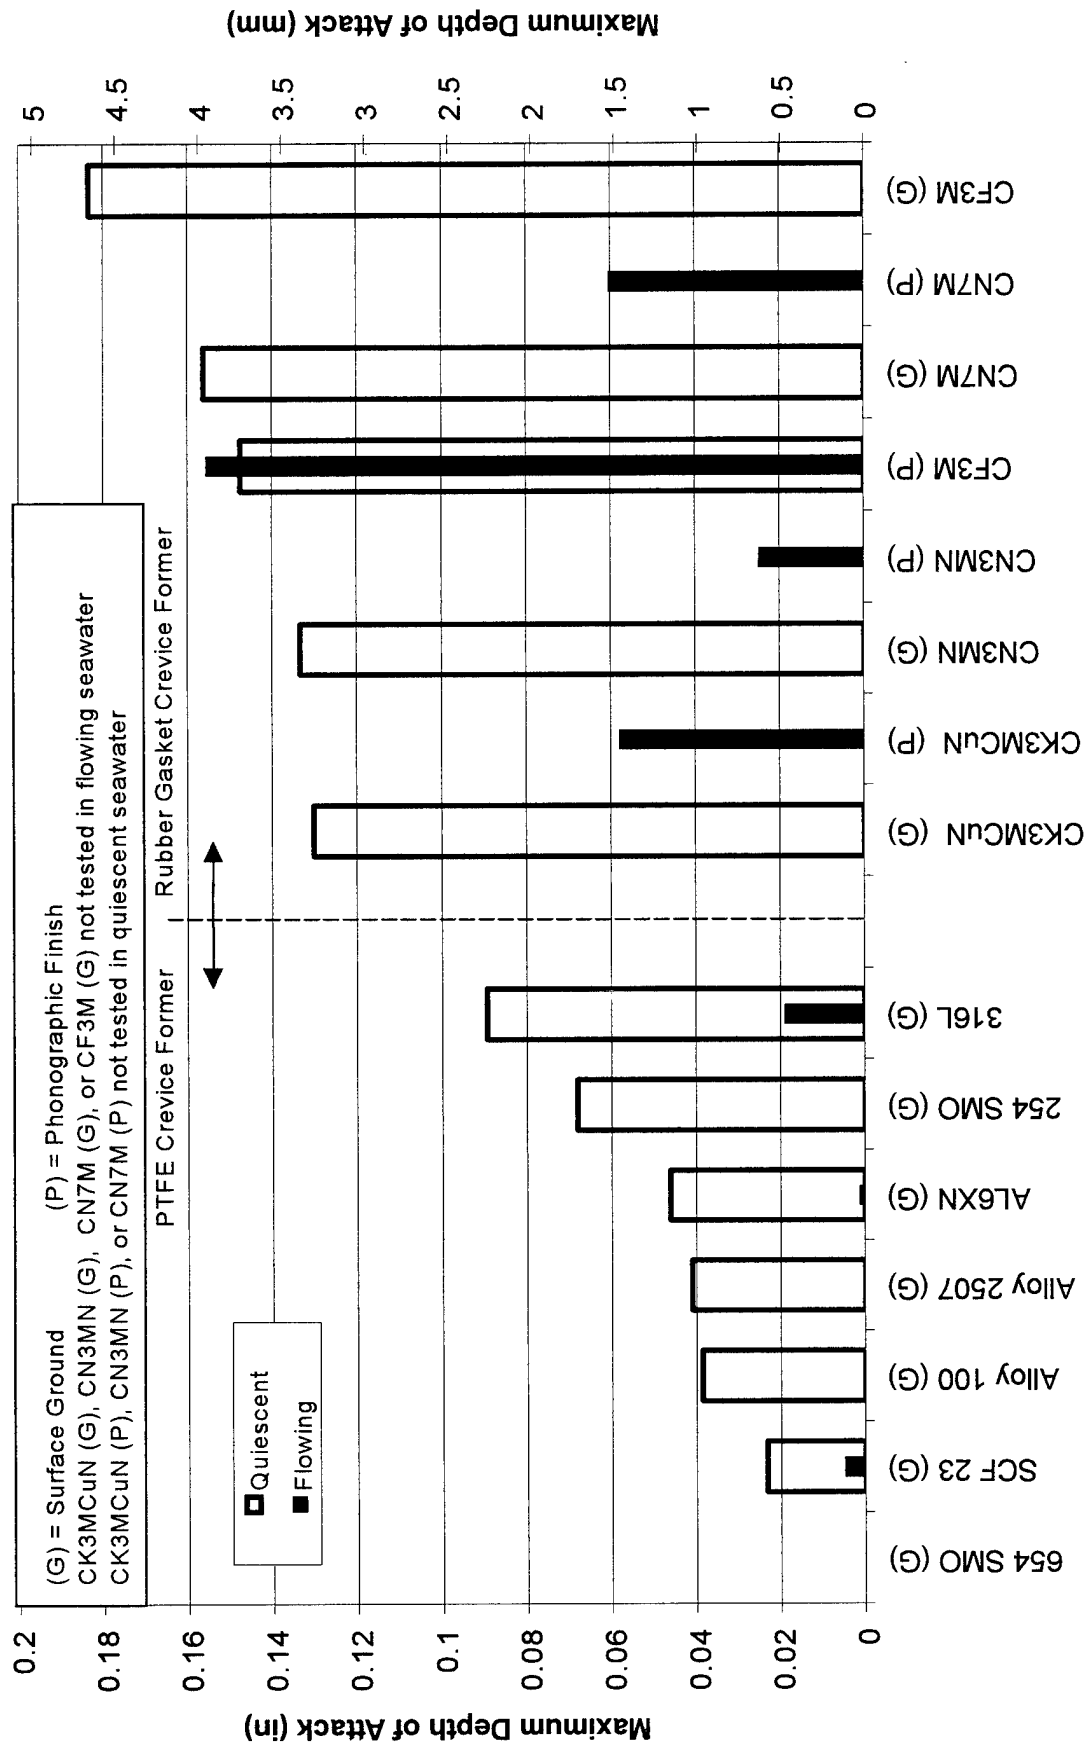
Figure 10. Maximum Depth of Attack Data for Stainless Steel Alloys After 180 Days in Quiescent and Flowing Natural Seawater

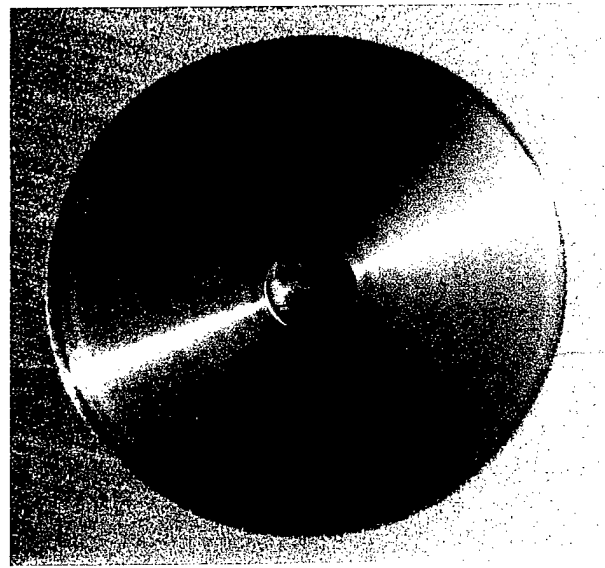
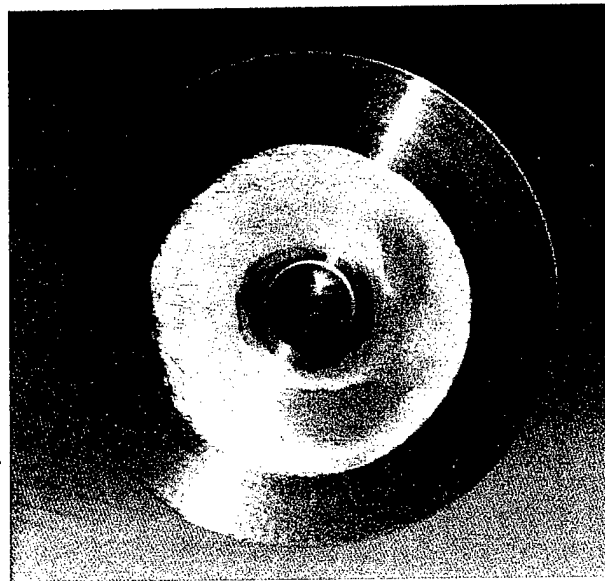
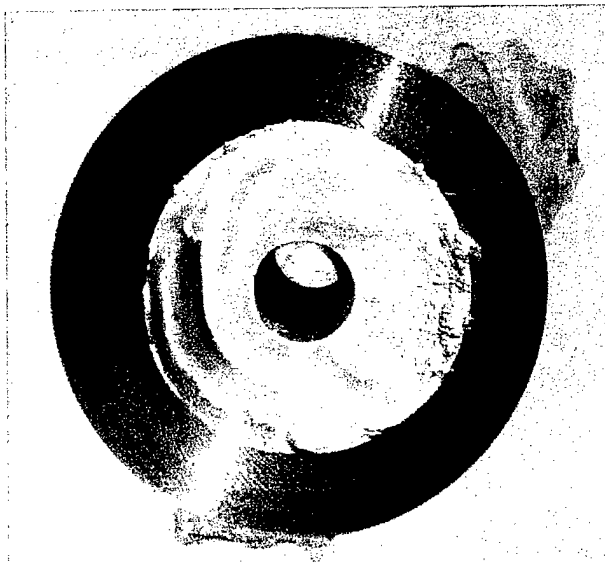
Figure 11. Wrought Stainless Steel Alloys After 180 Days in $85 \pm 5^\circ\text{F}$ ($29 \pm 3^\circ\text{C}$) Quiescent, Natural Seawater

Crevice corrosion results for the stainless alloys in quiescent seawater are provided in Table 5. Only one stainless alloy, superaustenitic 654 SMO, was fully resistant to crevice corrosion in the 180-day test. Another superaustenitic, SCF-23, ranked right below the 654 SMO in terms of maximum depth of attack (Figure 10). The SCF-23 specimens initiated crevice corrosion on only 2 of 4 crevice sites. The remaining stainless steels displayed significantly increased crevice corrosion. Although direct comparison is difficult due to the different crevice formers used in the tests, all of the cast alloys (rubber gasket crevice formers) had greater susceptibility than their wrought counterparts (PTFE crevice formers) based on maximum depth of attack (Figure 10). All crevice corrosion observed on stainless steels occurred under the crevice former. Figure 11 shows representative photographs of the varied attack present among the stainless steels tested, while Figure 12 exhibits the difference in crevice corrosion resistance between wrought AL6XN and its cast counterpart, CN3MN.

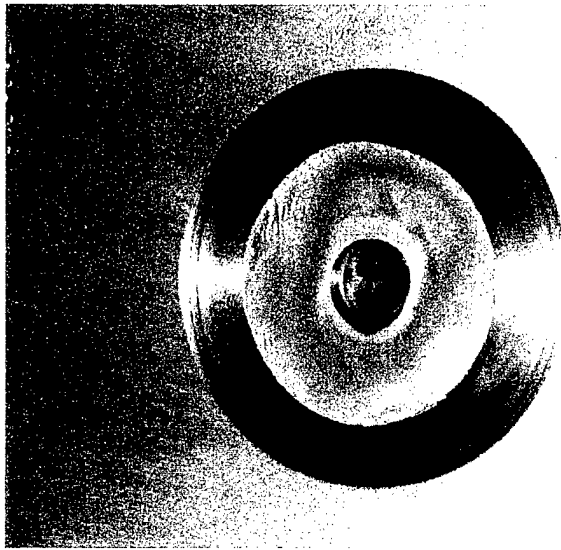
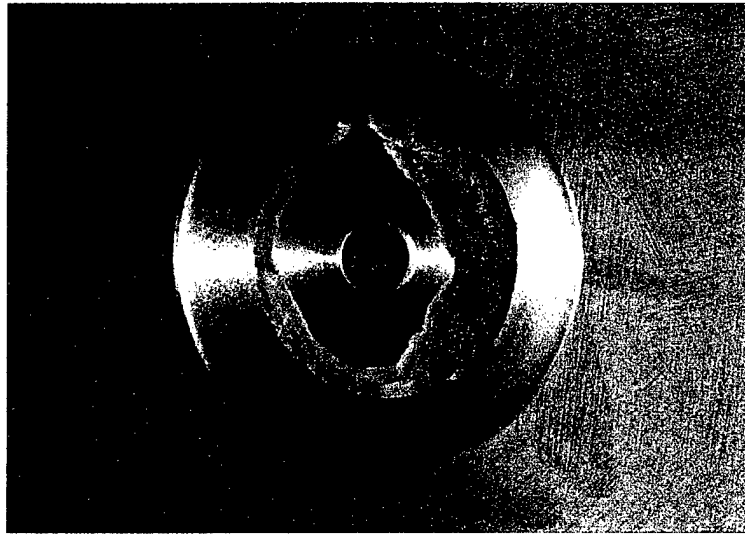
Figure 12. Wrought AL6XN and Cast CN3MN Crevice Specimens After 180 Days in $85 \pm 5^\circ\text{F}$ ($29 \pm 3^\circ\text{C}$) Quiescent, Natural Seawater

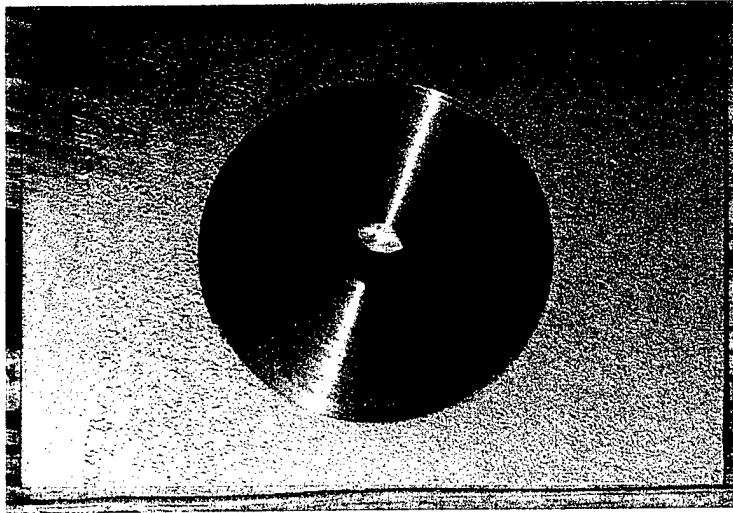
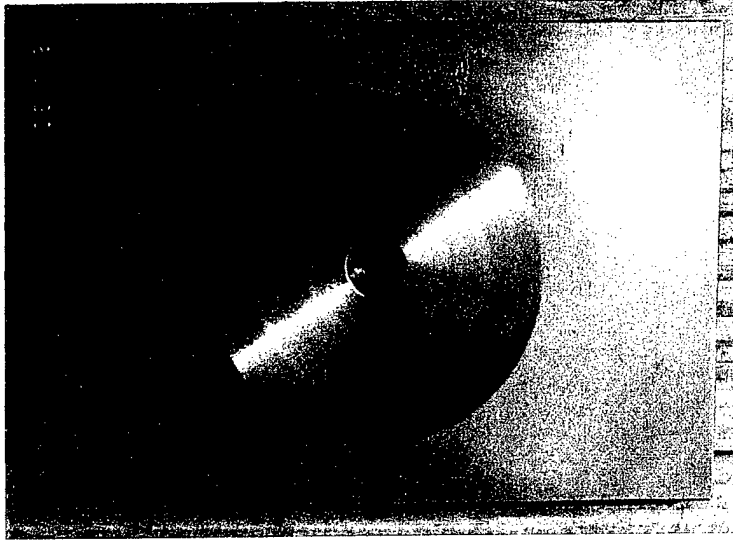
Figure 13. Titanium Alloys After 180 Days in $85 \pm 5^\circ\text{F}$ ($29 \pm 3^\circ\text{C}$) Quiescent, Natural Seawater

The titanium alloy results are also found in Table 5. All of the titanium alloys were fully resistant to crevice corrosion. No evidence of crevice corrosion was found under the rubber gasket or PTFE crevice formers, nor was there any corrosion of the boldly exposed surfaces on the Ti-45Nb, Ti-6Al-4V, or CP Ti specimens with and without anodizing (Figure 13).

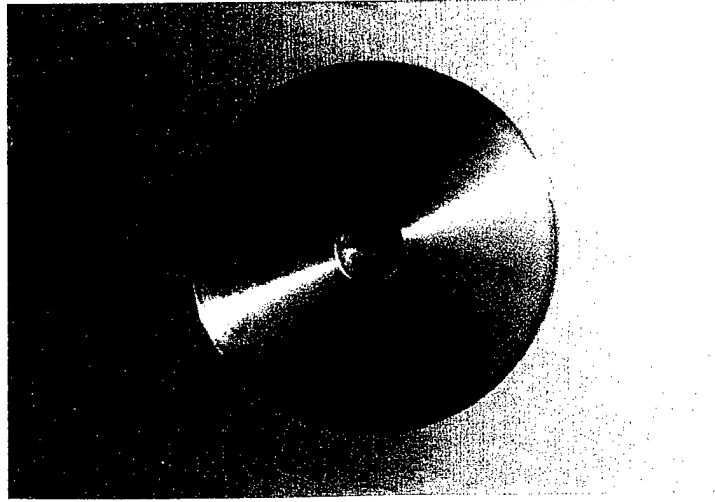
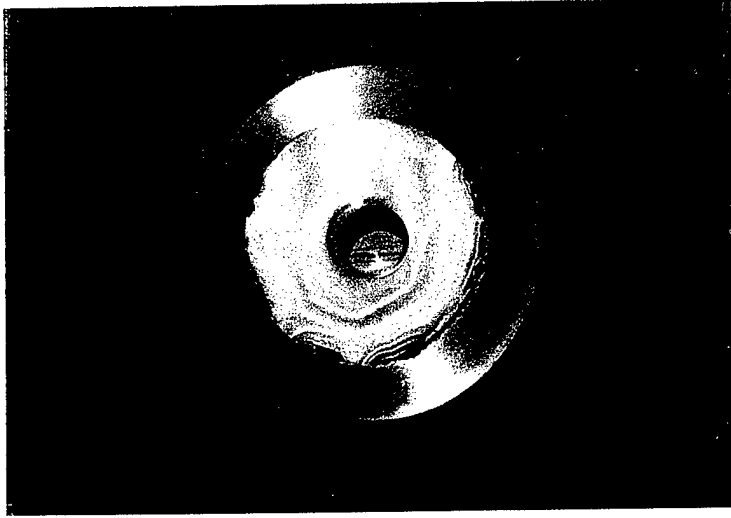
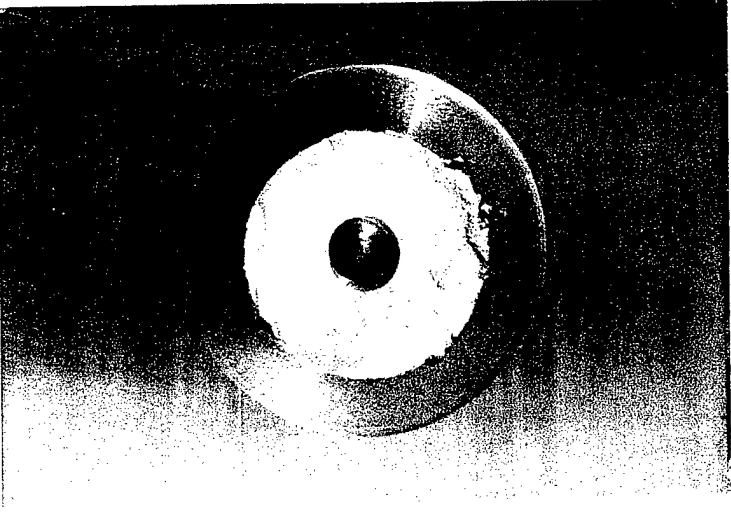
Figure 15. Representative Nickel-Base Alloy Crevice Specimens After 180 Days in $85 \pm 5^\circ\text{F}$ ($29 \pm 3^\circ\text{C}$) Quiescent, Natural Seawater

Crevice corrosion data for the nickel alloys under quiescent conditions are found in Table 6. Numerous alloys in this series were fully resistant to crevice corrosion, including wrought alloys C22, 686, 59, and C2000 and cast Alloy 59. Three other nickel alloys exhibited an increased susceptibility in comparison with the fully resistant alloys but were markedly improved compared to the remaining cast nickel alloys tested (Figure 14). These materials are wrought Alloys C276 and 625, and Alloy 625 Plus. In all cases where both cast and wrought versions of the same alloy were tested, the wrought materials consistently performed better than the castings. Again, this result may have been influenced by the different crevice formers used for the wrought and cast alloys. Representative photographs of cast and wrought nickel-base alloys are found in Figures 15 and 16. Cast CW6MC, the only nickel alloy where both surface ground and phonographic finishes were evaluated, showed slightly improved resistance in the phonographic condition (Figure 17). Similar to the stainless steels, crevice corrosion of the nickel base alloys occurred under the crevice former.

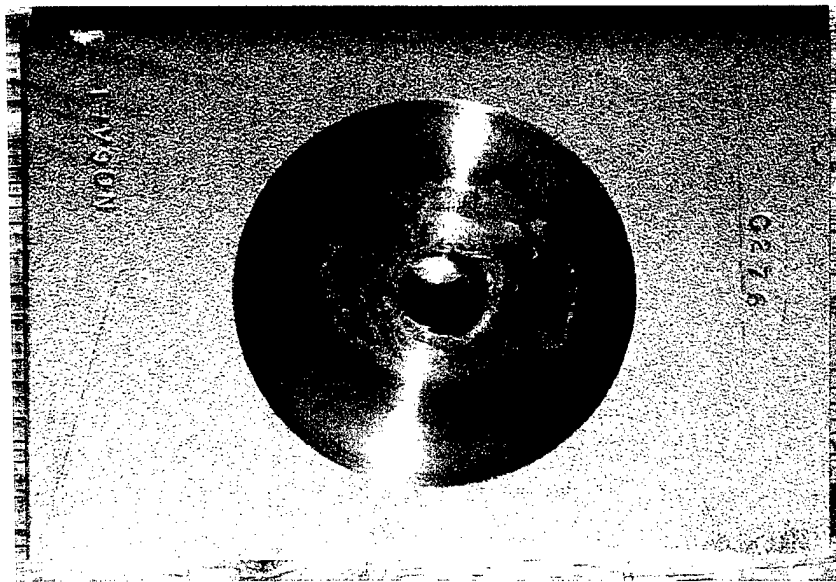
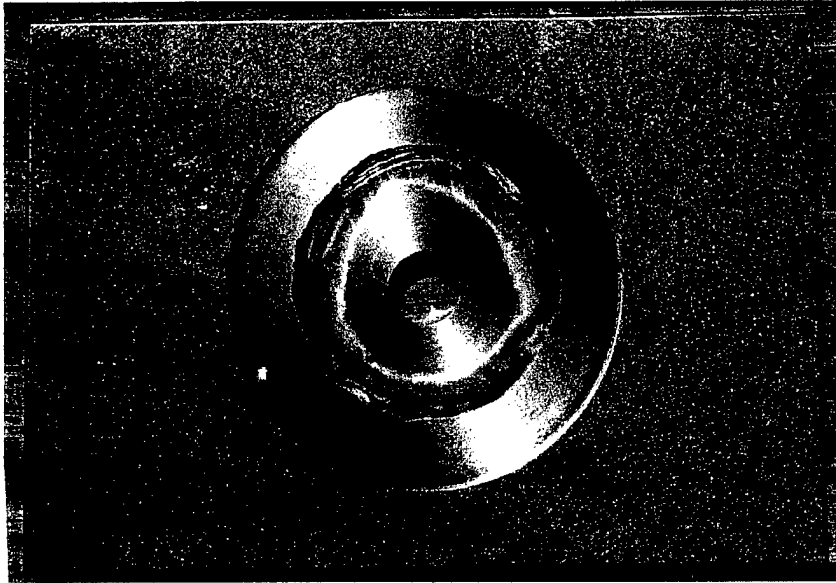
Figure 16. Wrought C276 and Cast CW12MW Crevice Specimens After 180 Days in $85 \pm 5^\circ\text{F}$ ($29 \pm 3^\circ\text{C}$) Quiescent, Natural Seawater

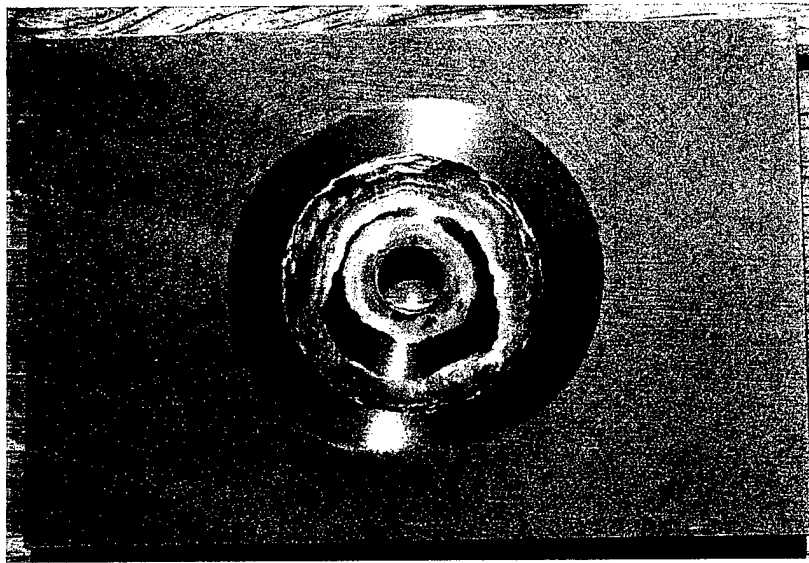
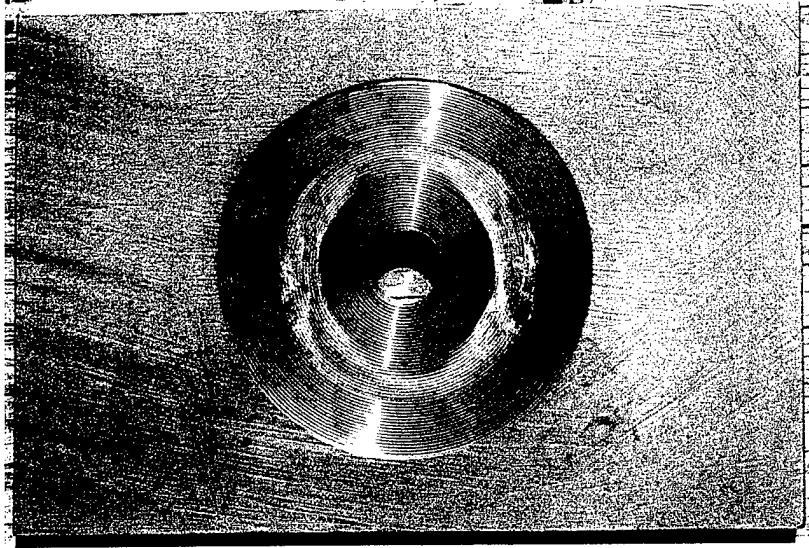
Figure 17. Cast CW6MC Crevice Specimens with Surface Ground and Phonographic Finishes After 180 Days in $85 \pm 5^\circ\text{F}$ ($29 \pm 3^\circ\text{C}$) Quiescent, Natural Seawater

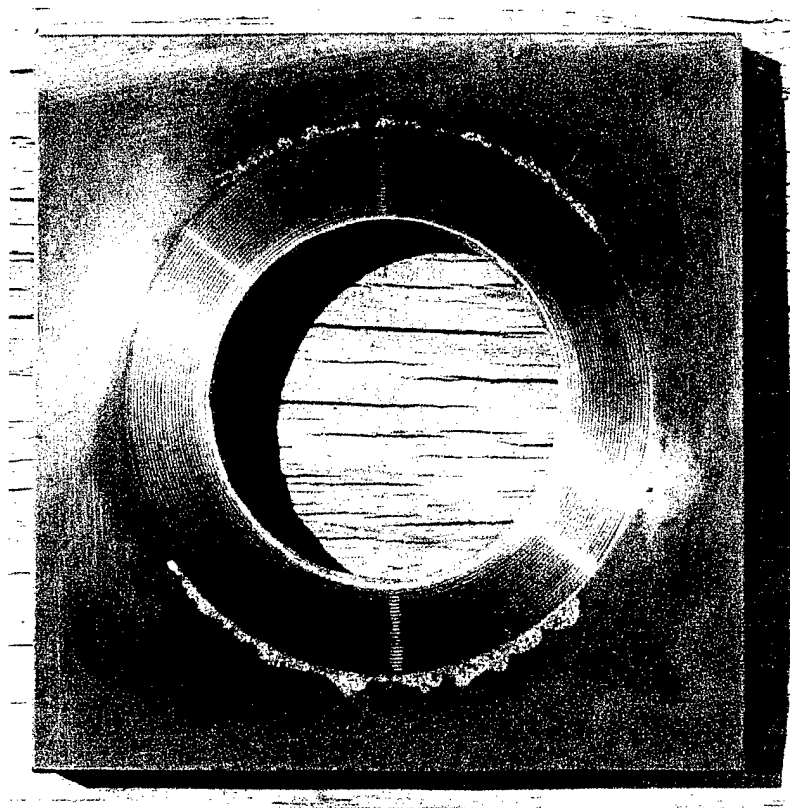
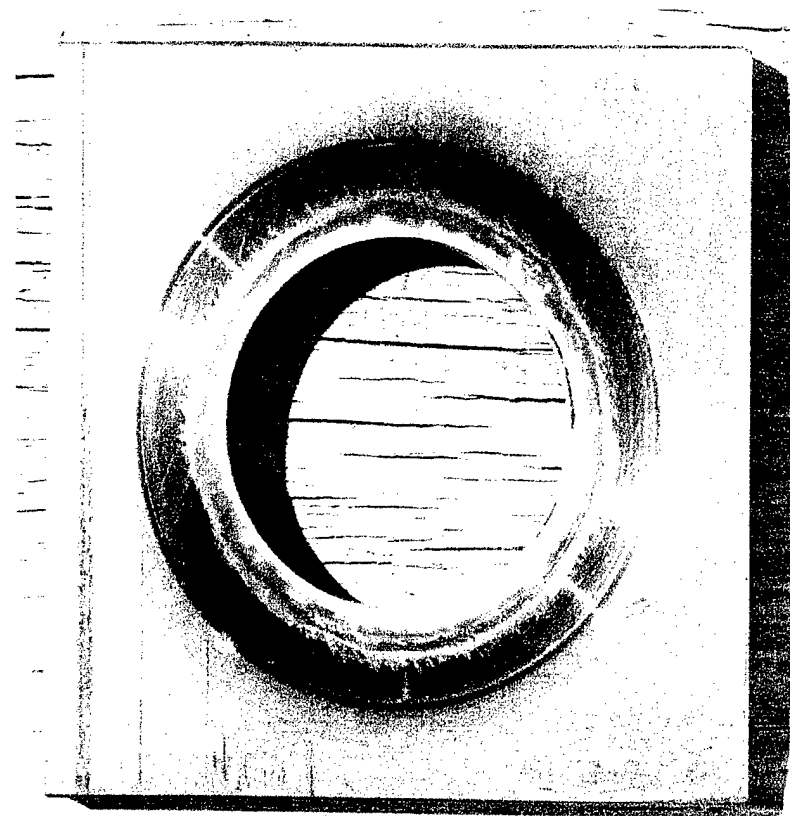
Figure 18. Cast M35 and Wrought Alloy 400 After 180 Days in 6 ft/sec (1.8 m/sec)
Flowing Natural Seawater

Crevice corrosion initiated under the PTFE at all four crevice sites on the wrought Alloy 400 specimens (Figure 18). Localized attack was also present on the Alloy 400 bore surfaces. The average mass loss for the cast and wrought 70/30 Cu-Ni specimens was similar, but the occurrence of localized corrosion differed. The wrought 70/30 Cu-Ni specimens exhibited attack under the crevice, while the cast specimens showed slight corrosion immediately adjacent to the crevice former.

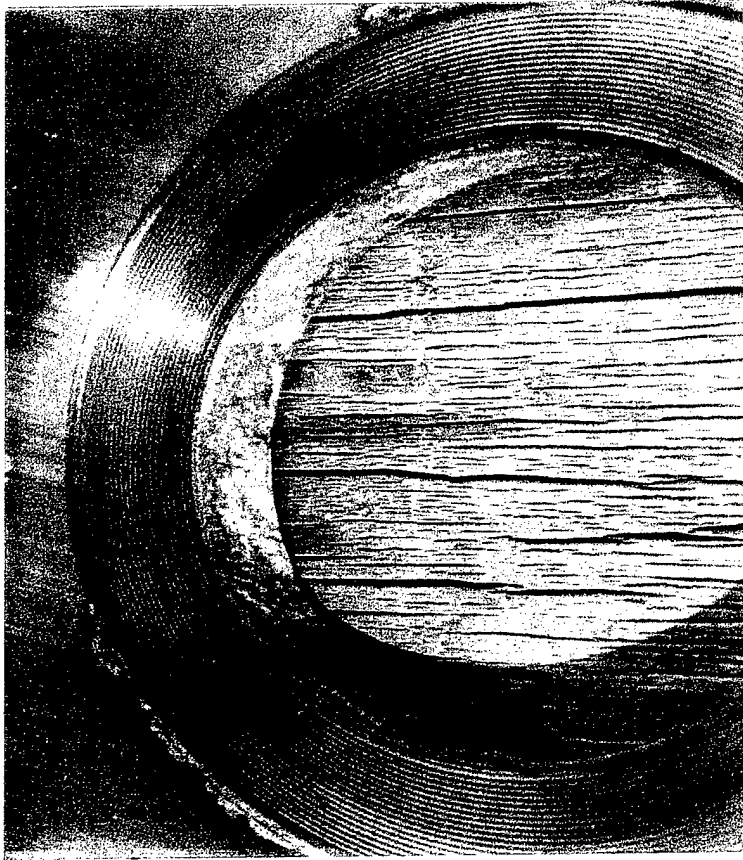
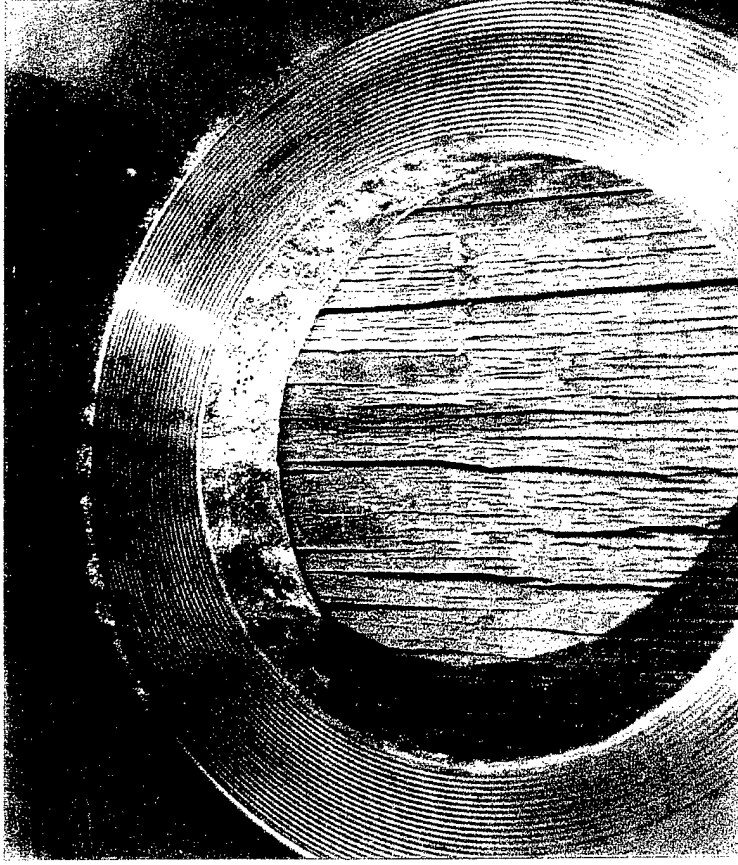
Figure 19. Interior Bore Surfaces of Cast Ni Al Bronze and M35 After 180 Days in 6 ft/sec (1.8 m/sec) Flowing Natural Seawater

The extent of mass loss for the M Bronze specimens was significantly less than for the Ni Al Bronze. The majority of the attack on the Ni Al Bronze and M Bronze specimens was within the bore surfaces, which was expected on these copper alloys due to the close proximity of the crevice area and the fact that the bore surfaces are anodic to the crevice area. Like one of the M Bronze specimens, cast M35 exhibited corrosion on the boldly exposed surfaces outside the machined area and no corrosion under the rubber gasket (Figure 18). Cast M35 additionally exhibited substantial pitting of the bore surfaces. The excessive mass loss reported for M35 Specimen B was presumably due to a dead short between the specimen and the titanium piping that was suspected based on corrosion potential measurements after 6 weeks' exposure. The mass loss reported for M35 Specimen A was similar to the average mass loss on the Ni Al Bronze specimens. Figure 19 depicts the corrosion present on the interior bore surfaces of cast Ni Al Bronze and M35.
